Manhole Inspection Summary

Manhole # S17I__008MH

Location Address: **2410 hollins st**

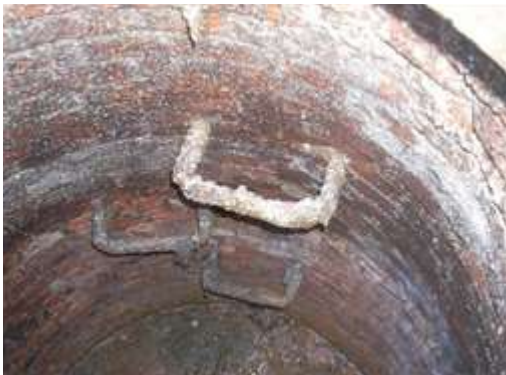
Defect 3

☒ **Evidence Of Surcharge** Depth: **6** (ft.) ☐ Active Surcharge Present

surcharge evidence on the steps

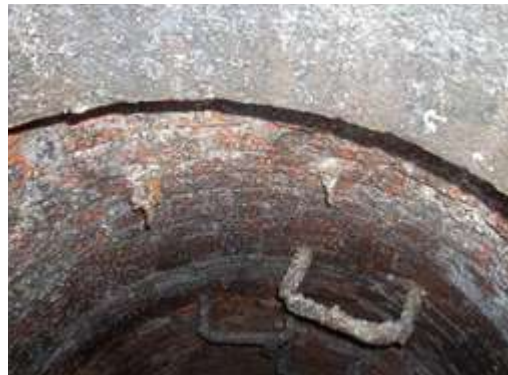
Defect 2

Count: **3** Missing: **1** ☒ **Corroded**

corroded and missing step

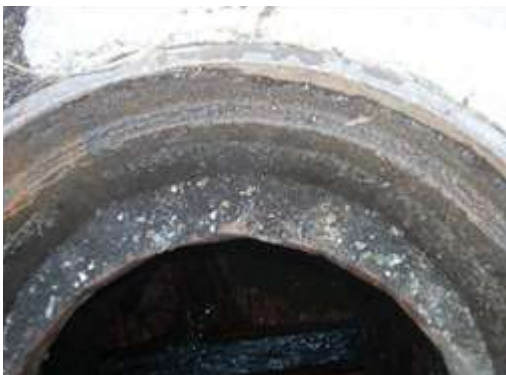
Defect 1

Offset: **2** (in.)

frame offset

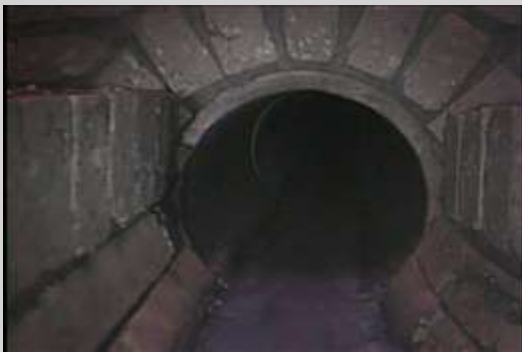
12 O'Clock Outflow

10 in. Circular Gravity Sewer
Pipe Out @ 12 O'Clock

Pipe Height: **10.8** (in.) Rod and Bar (Angled)
Pipe Material: **Clay** ☐ Pipe Lined
Invert Depth: **8.28** (ft.) Flow Characteristics: **Slow**
Deposits: ☒ None ☐ Mud ☐ Sludge ☐ Debris ☐ Grease
Silt Depth: **0** (in.) Deposits Extent:
Infiltration: **None** Pipe Seal Cond: **Sound**

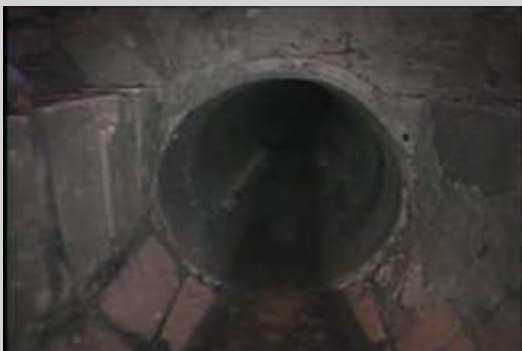
3 O'Clock Inflow

8 in. Circular Gravity Sewer
Pipe In @ 3 O'Clock

Pipe Height: **8.4** (in.) Rod and Bar (Angled)
Pipe Material: **Clay** ☐ Pipe Lined
Invert Depth: **7.90** (ft.) Flow Characteristics: **Slow**
Deposits: ☒ None ☐ Mud ☐ Sludge ☐ Debris ☐ Grease
Silt Depth: **0** (in.) Deposits Extent:
Infiltration: **None** Pipe Seal Cond: **Sound**

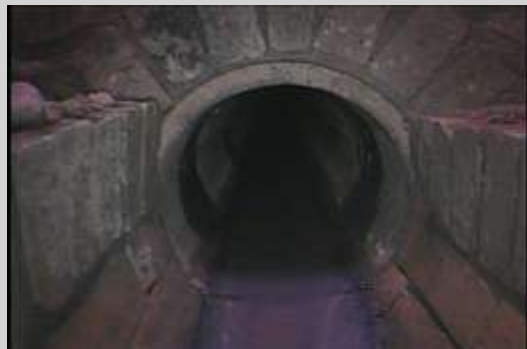
6 O'Clock Inflow

10 in. Circular Gravity Sewer
Pipe In @ 6 O'Clock

Pipe Height: **10.8** (in.) Rod and Bar (Angled)

Pipe Material: **Clay** ☐ Pipe Lined

Invert Depth: **8.15** (ft.) Flow Characteristics: **Slow**

Deposits: ☒ None ☐ Mud ☐ Sludge ☐ Debris ☐ Grease

Infiltration: **None** Pipe Seal Cond: **Sound**
